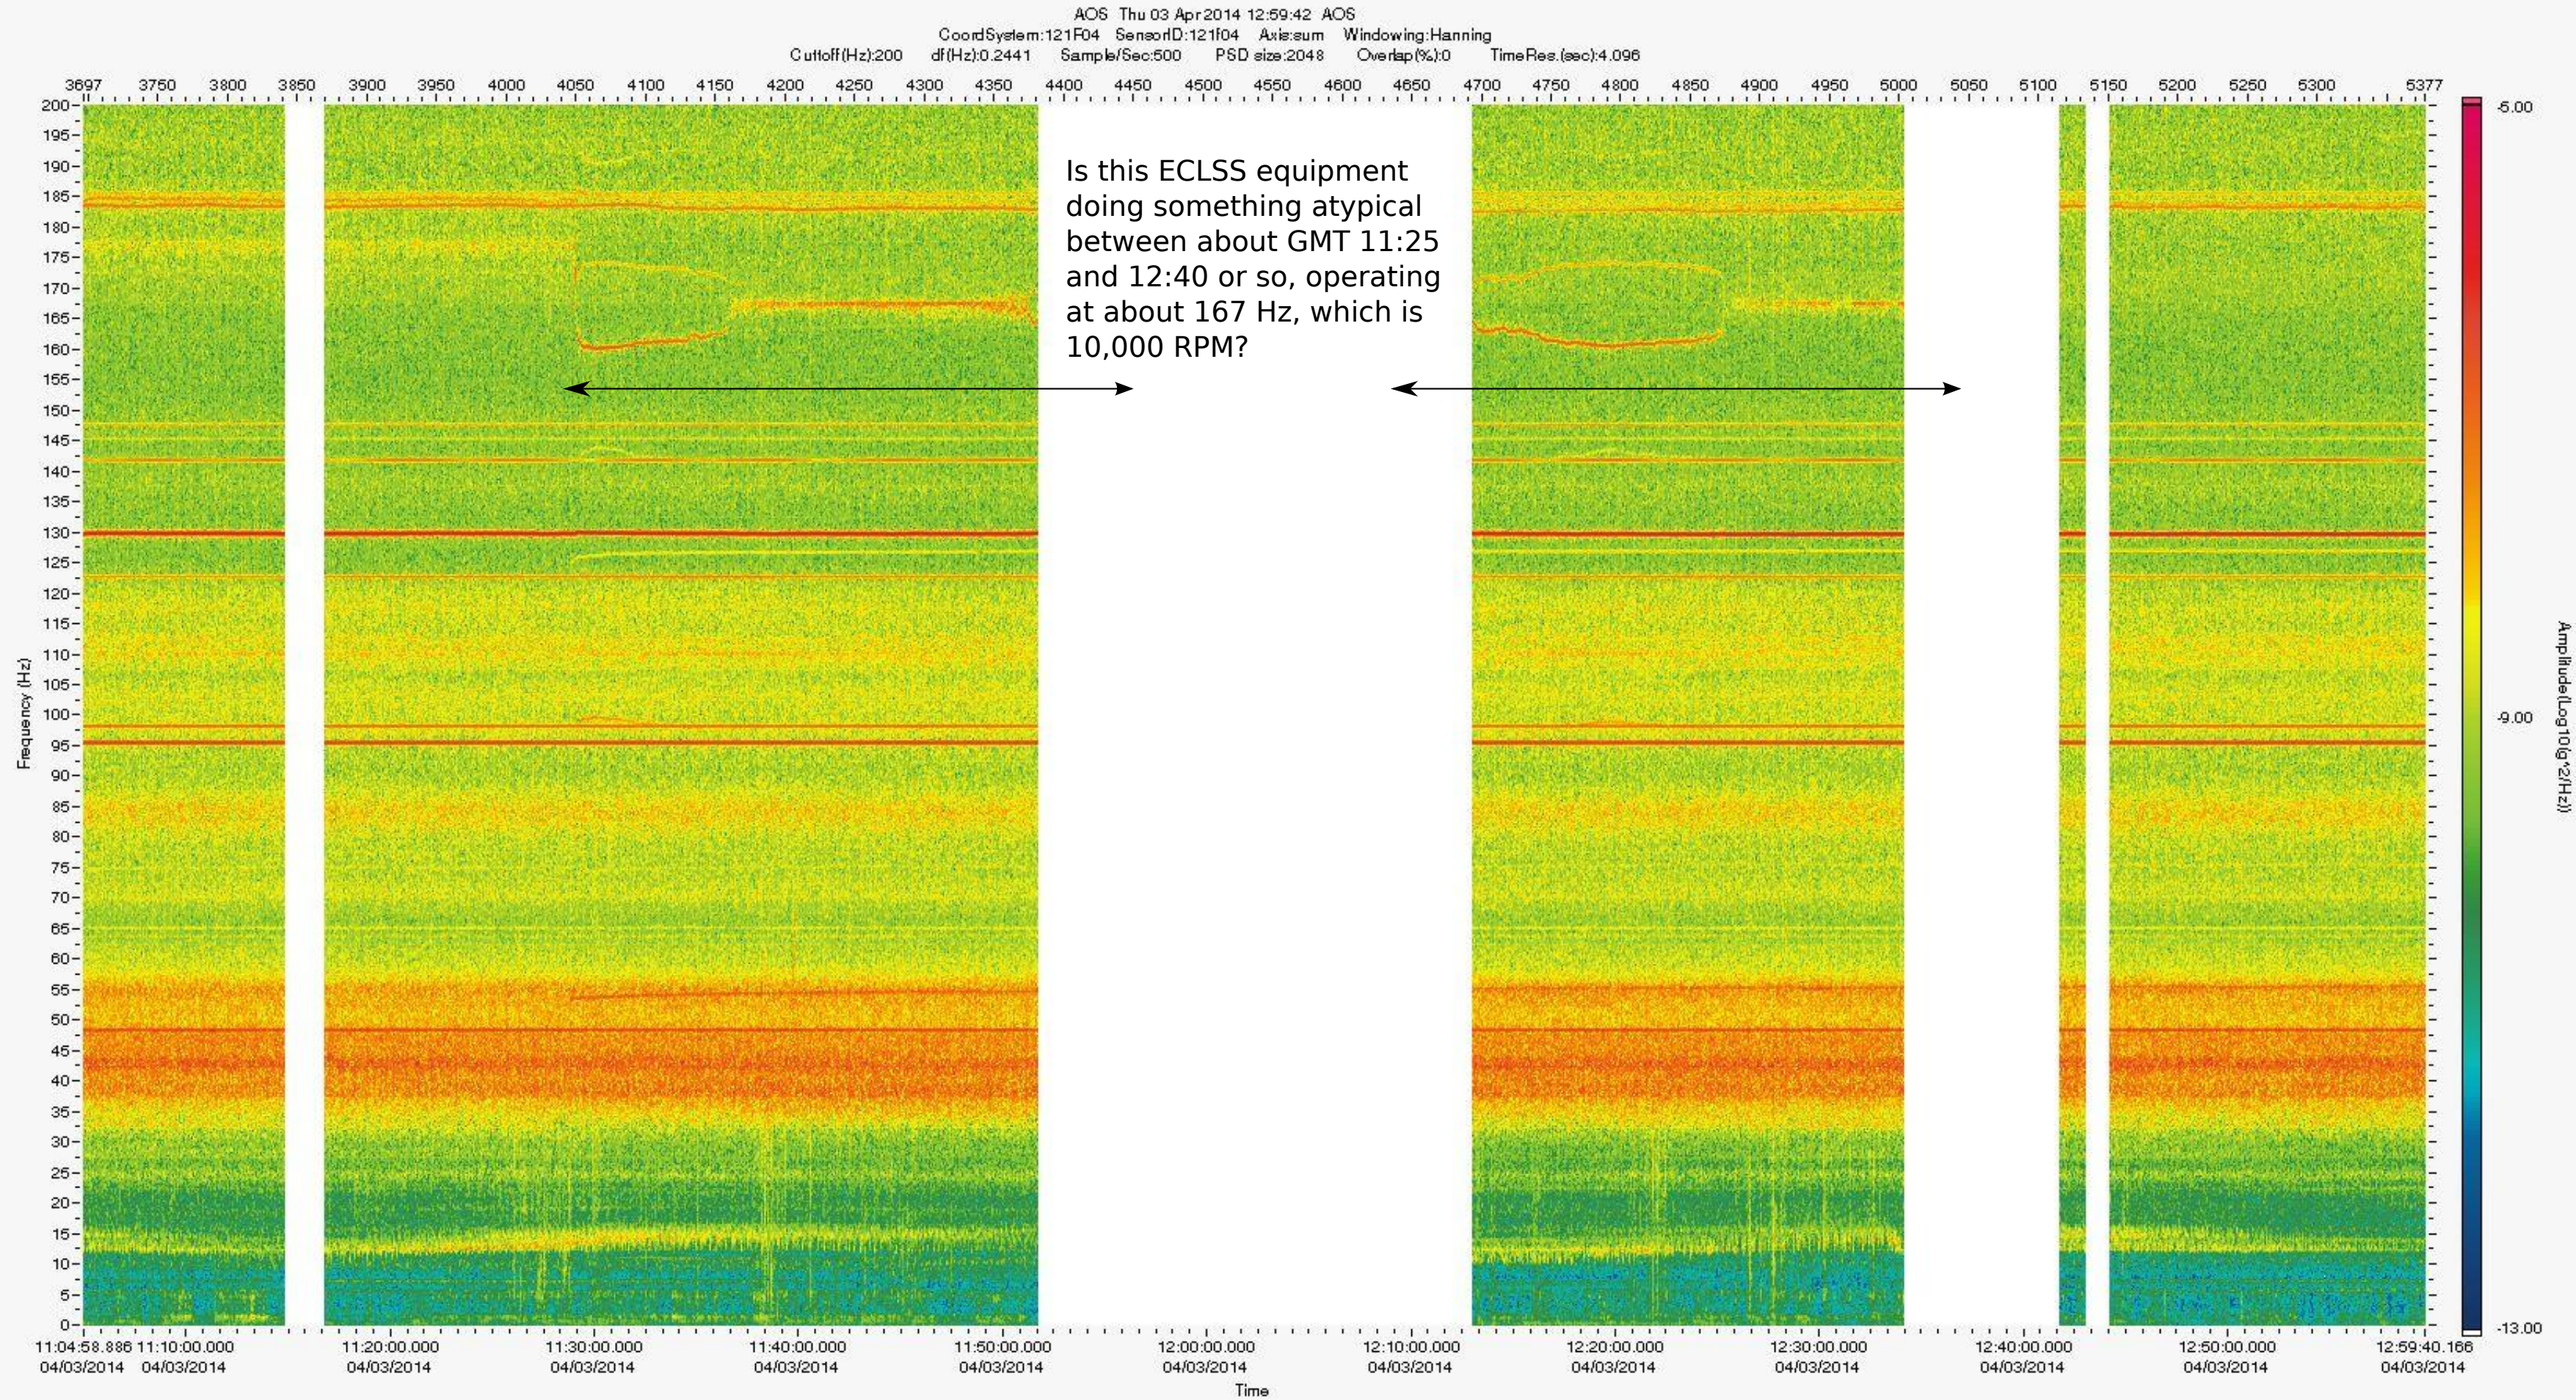
AOS Thu 03 Apr 2014 12:59:42 AOS
CoordSystem:121F04 SensorID:121f04 Axis:sum Windowing:Hanning
Cuttoff(Hz):200 df(Hz):0.2441 Sample/Sec:500 PSD size:2048 Overlap(%):0 TimeRes.(sec):4.096
Is this ECLSS equipment doing something atypical between about GMT 11:25 and 12:40 or so, operating at about 167 Hz, which is 10,000 RPM?
Frequency (Hz)
Time
Amplitude(Log10(g^2/Hz))
-5.00
-9.00
-13.00
